Inspection Report

Property Address:
3114 Ne Barnes St
Portland OR 97212

Insight Property Inspection

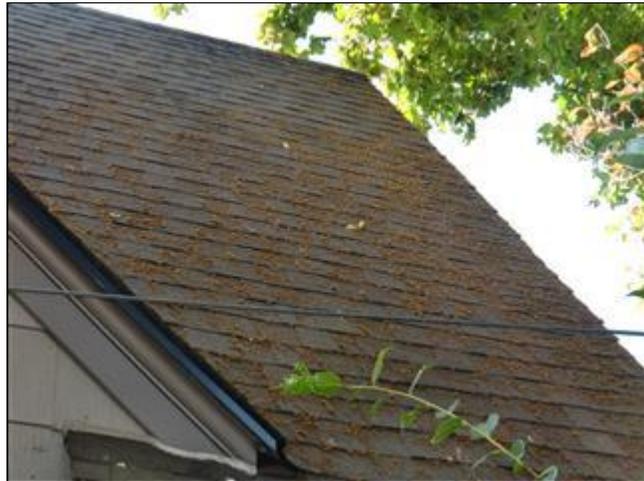
1.0 Picture 1

Organic matter growing on the roof can dramatically shorten the life of the shingles. I recommend a roof maintenance company take measures to safely and effectively remove this matter without damaging the composition shingles. NOTE: Power washing can remove the protective granules from the shingles causing permanent damage. I recommend only qualified and experienced contractors use this method of removal.

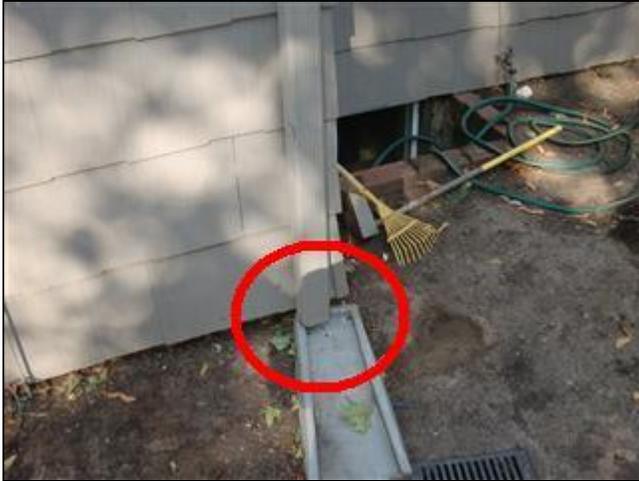
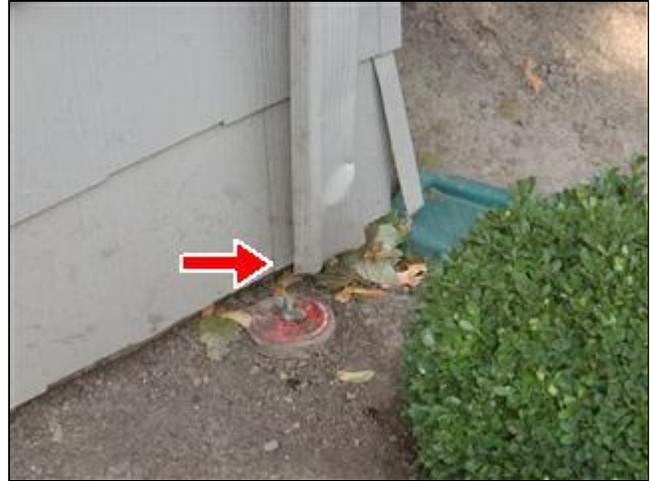
The gutter downspouts need to be extended away from the foundation at least 6'. Ensure that water flows away from the structure.

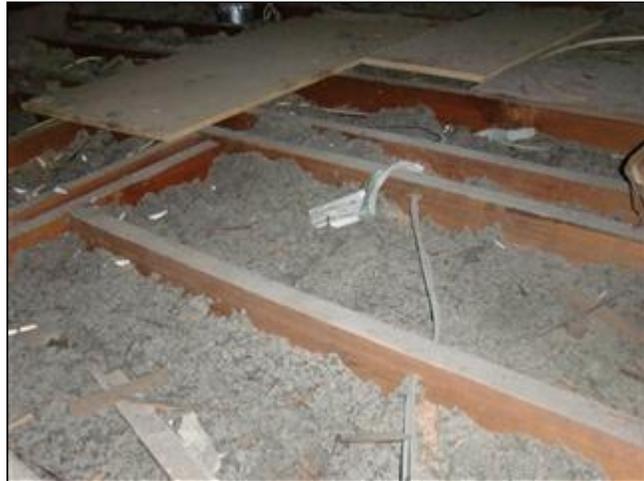
1.7 Picture 1

I recommend adding more insulation in the attic to improve overall thermal efficiency of the home.

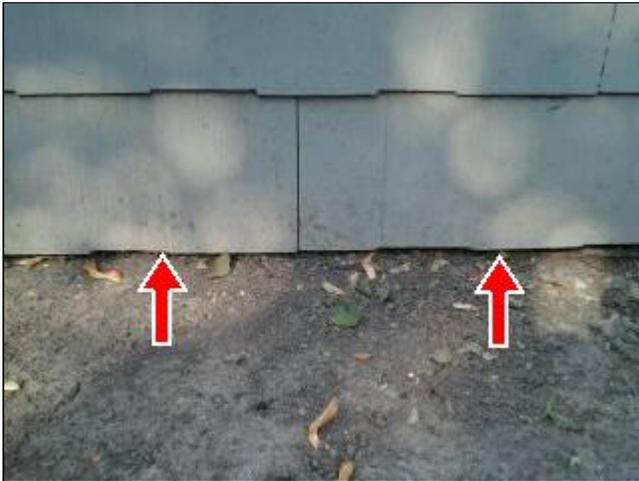
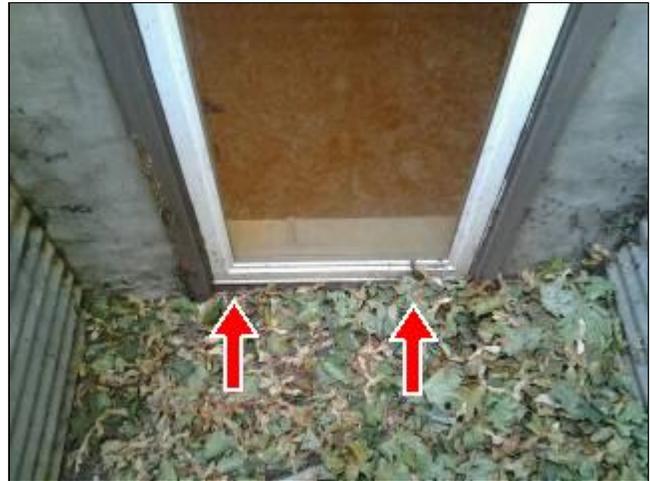
(1) Wood to earth contact is noted at the siding and trim around the basement windows. This can cause rot and invites unwanted pests including but not limited to termites and carpenter ants, into the home. I recommend 4" to 6" of clearance between siding and earth.

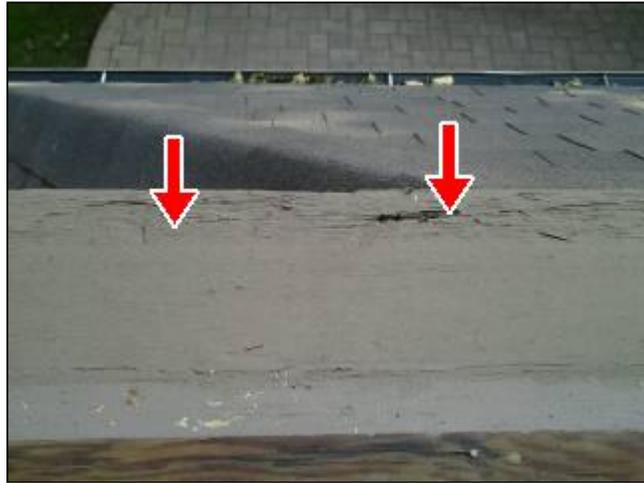
2.0 Picture 3 stairwell windows

(3) Rot is noted around some of the trim surrounding windows. All damaged wood should be removed and replaced with new.

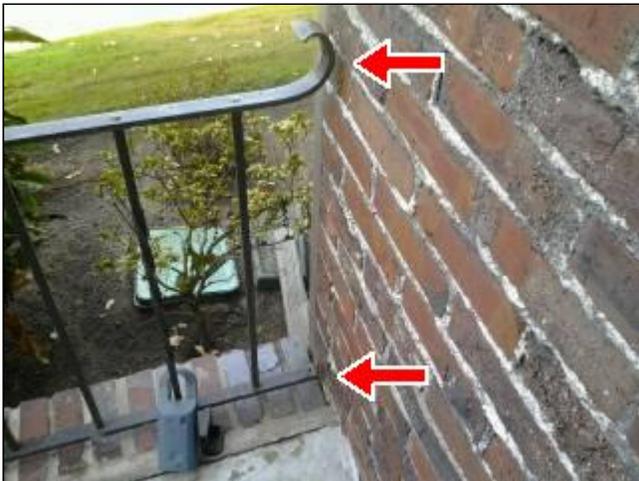
2.3 Picture 1

The handrails at the front porch are not secure. I recommend a licensed contractor evaluate and make repairs as appropriate to ensure safe handrails/railings.(Picture 1)

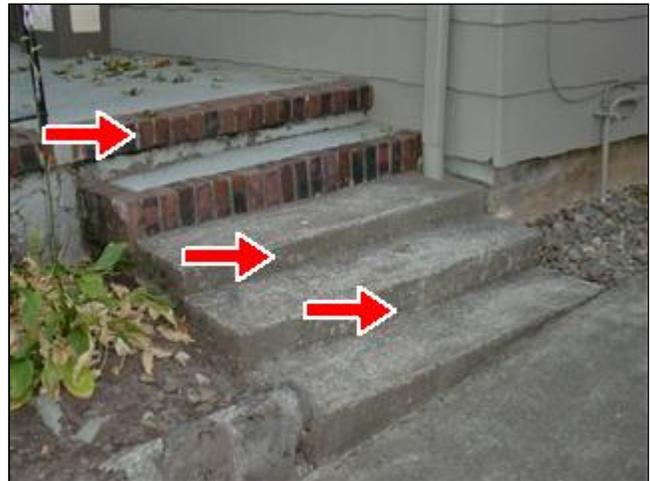
2.3 Picture 2

The steps to the front entry are of different heights. This poses a trip hazard. As a safety precaution I recommend these steps be built with even rise and run.(Picture 2)

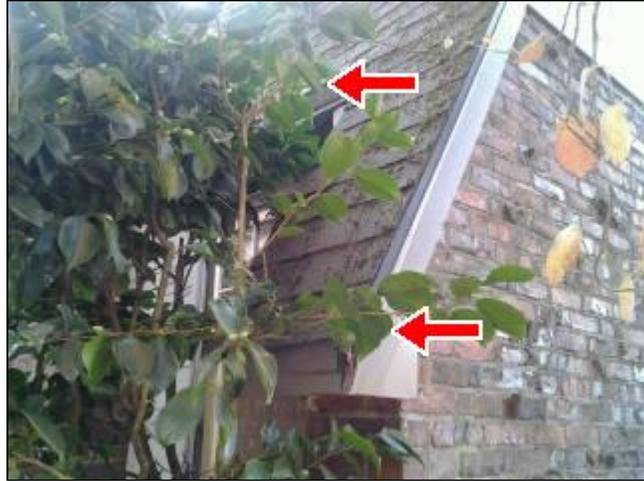
2.4 Picture 1

(1) Vegetation touching the house should be trimmed and maintained 6" to 8" from the structure to help prevent damage to the paint/siding and to help deter unwanted pests and moisture.

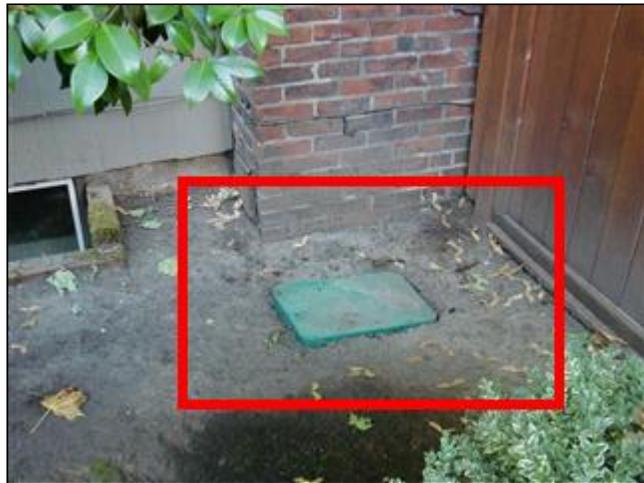
2.4 Picture 2

(2) There is a negative slope towards the home. Grading should fall away from the structure/foundation for at least 6'. Where this is not possible, drainage should be provided. I am unable to determine if sub surface drainage has been installed.

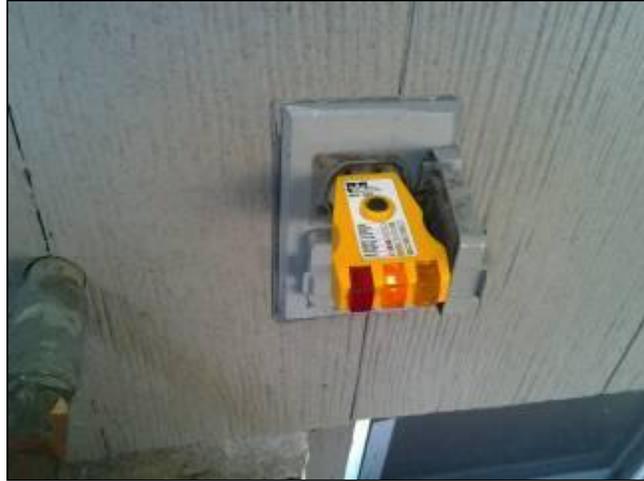
2.7 Picture 1

Exterior outlets indicate an open ground and are not GFCI protected. This is a safety item and corrections are advised by a licensed electrical contractor.

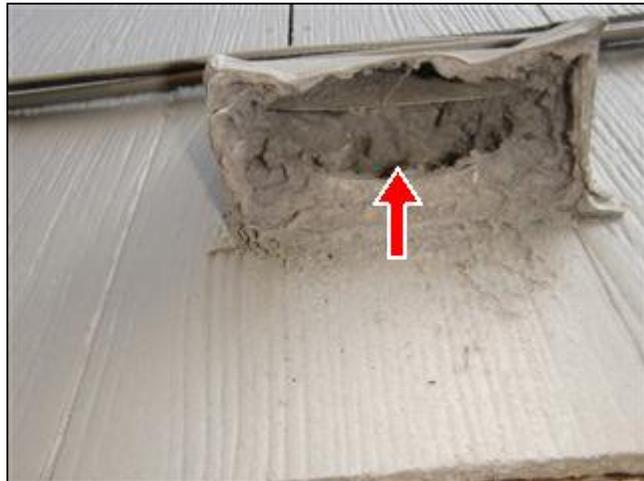
2.8 Picture 1

The louver/baffle at the exterior is damaged, missing, or otherwise stuck open. This device should be repaired or replaced to prevent unwanted pests from entering the dryer venting and nesting or causing damage.

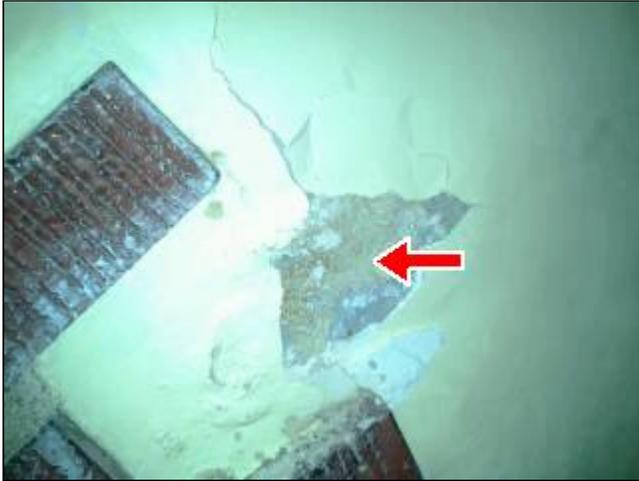
White efflorescence (powder substance) on block wall indicates moisture is in contact with the masonry. This does not necessarily indicate that intrusion will occur. I recommend checking the gutters and the downspout drain lines for proper operation. Efflorescence is found on many homes without water intrusion occurring inside the home. But, it should alert you to the possibility that future steps may be needed.

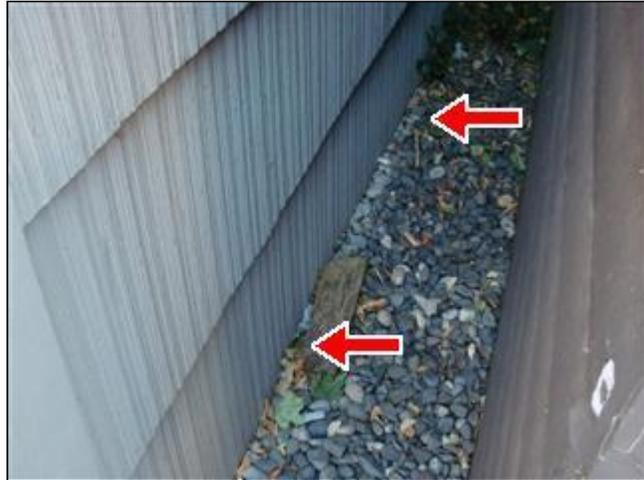
4.0 Picture 1

Wood to earth contact is noted at the siding. This can cause rot and invites unwanted pests including but not limited to termites and carpenter ants, into the home. I recommend 4" to 6" of clearance between siding and earth.

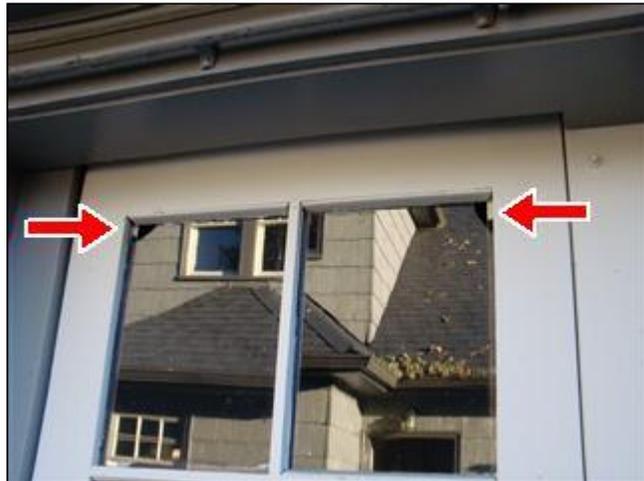
4.1 Picture 1

Some of the windows are broken. I recommend all broken panes be replaced.

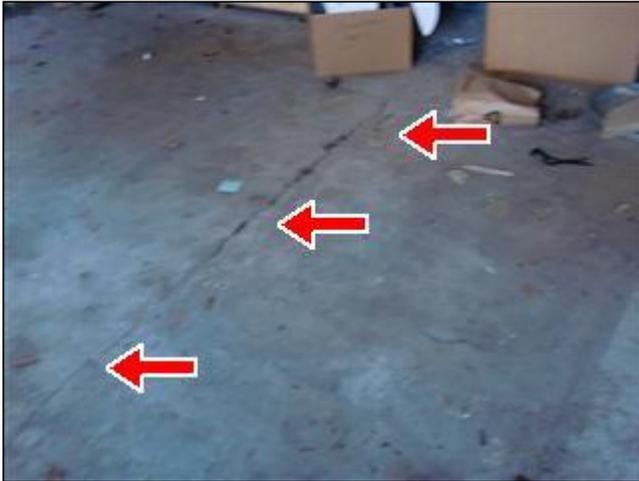
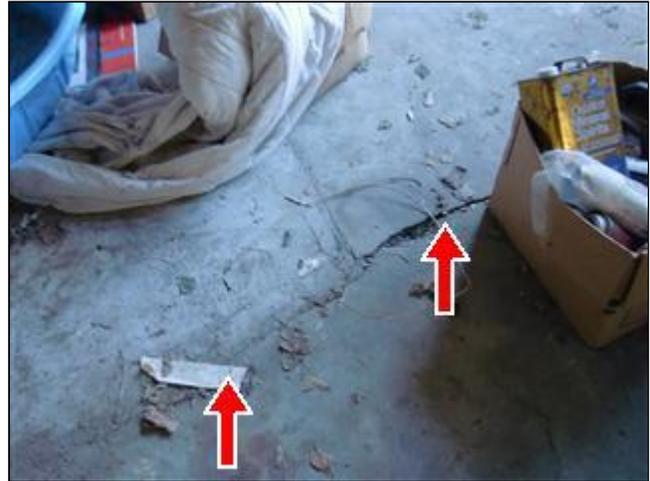
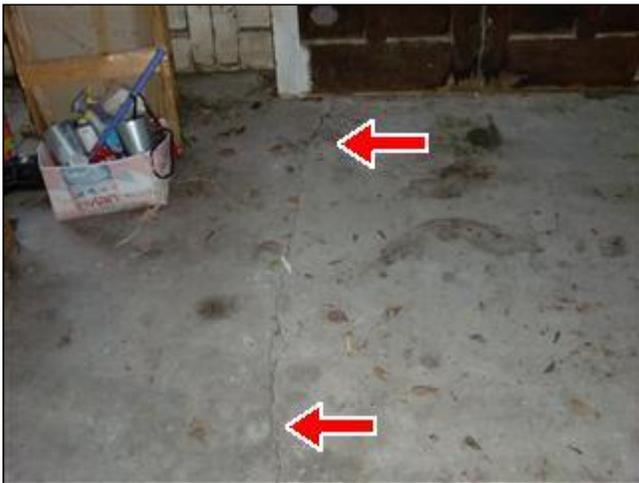
Major settlement cracks are noted in the garage floor. It appears that additional concrete has already been applied at the top of the floor to level it out. Repair or replace this floor as necessary.

Several cracks in the garage foundation are also noted. I am unable to determine the amount of settling or if this structure will continue to settle over time. A licensed foundation contractor or structural engineer should evaluate for repairs or recommendations as appropriate.

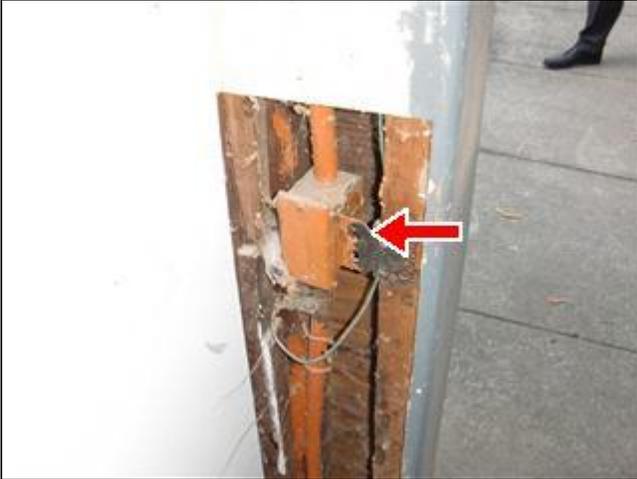
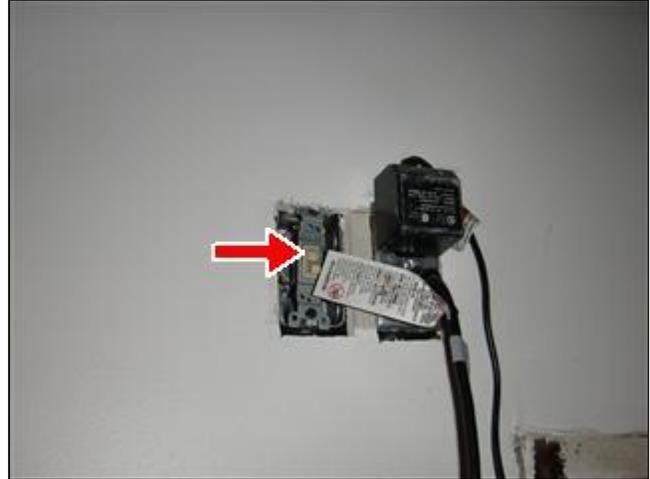
- A separate electrical junction box is needed in the garage.
- Many of the outlets or switches do not have covers installed.
- Outlets in the garage should be GFCI protected

A licensed electrician should make corrections as necessary.

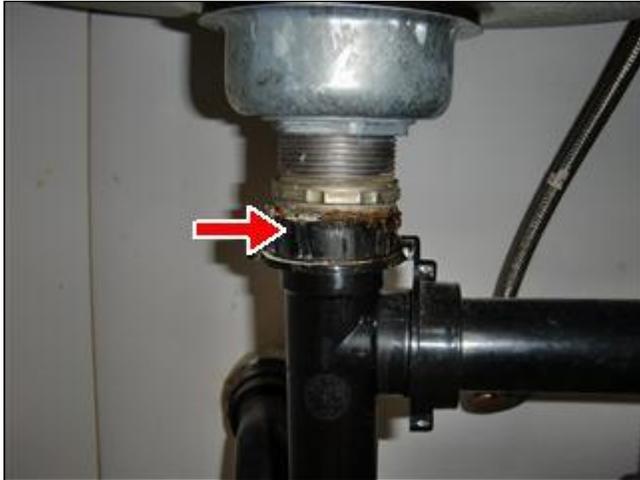
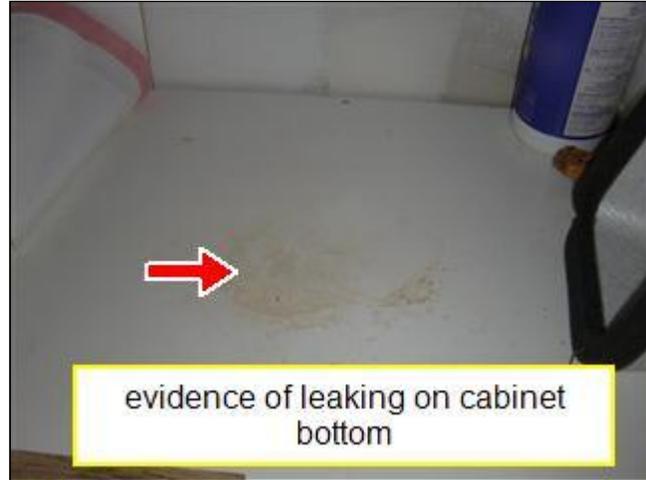
Loose, improper or sub-standard plumbing is noted under the sink. Repairs are needed.

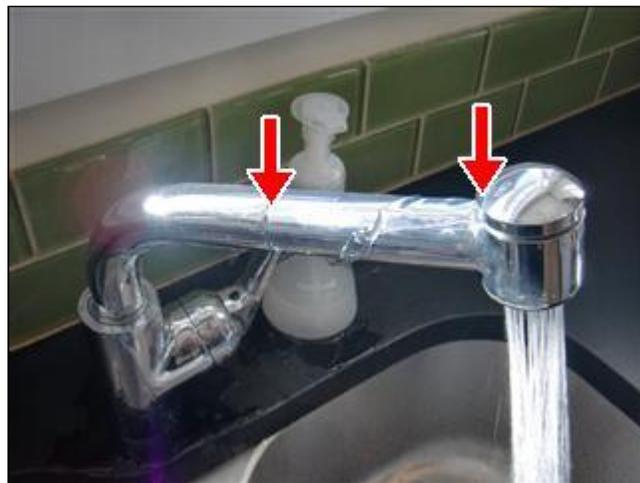
5.7 Picture 1

The sprayer at the kitchen faucet is leaking and needs repairing or replacement.

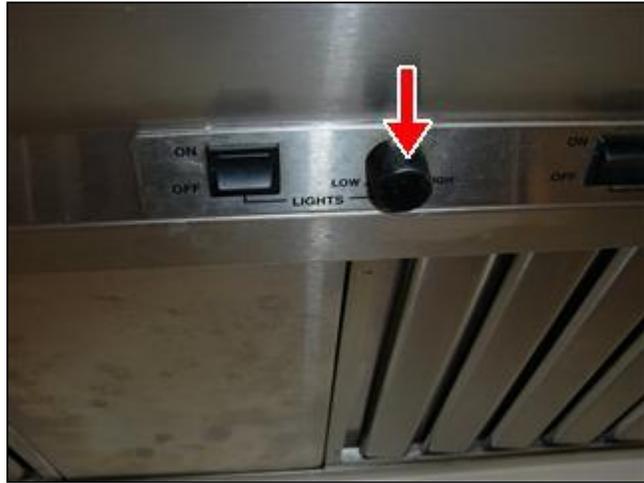
5.11 Picture 1

The dimmer function on the vent hood lights did not function at the time of inspection. Repairs are needed for this feature to work

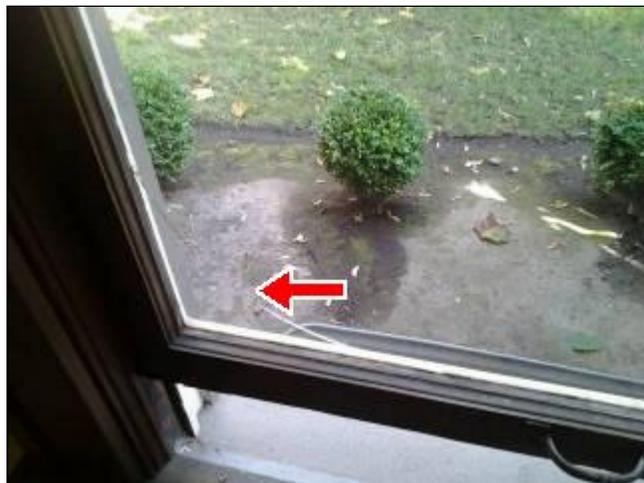
6.4 Picture 1 back left bedroom

There are cracked panes of glass in some windows throughout home.

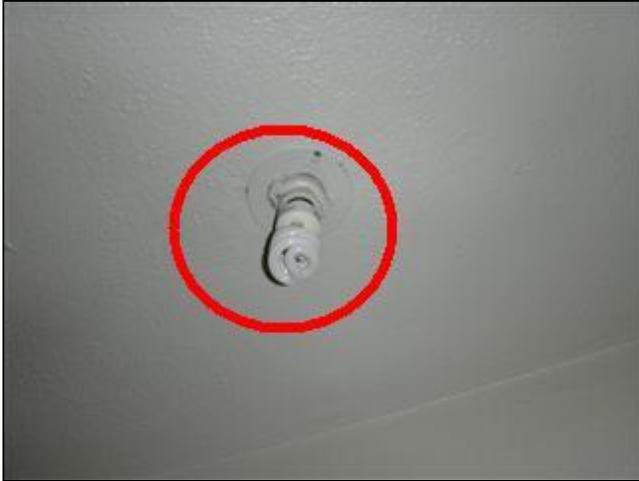
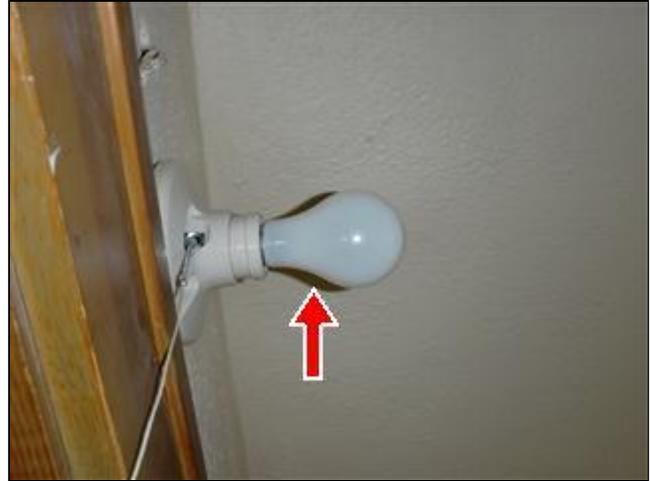
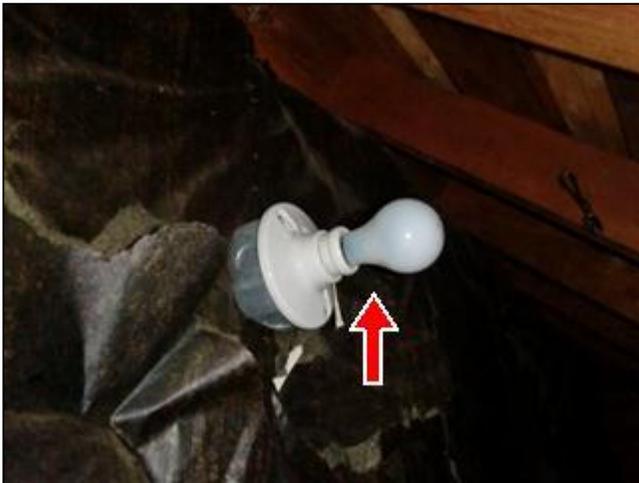
Globeless fixtures in closets or areas used for storage are a fire hazard. I recommend replacing these fixtures with ones with globes.

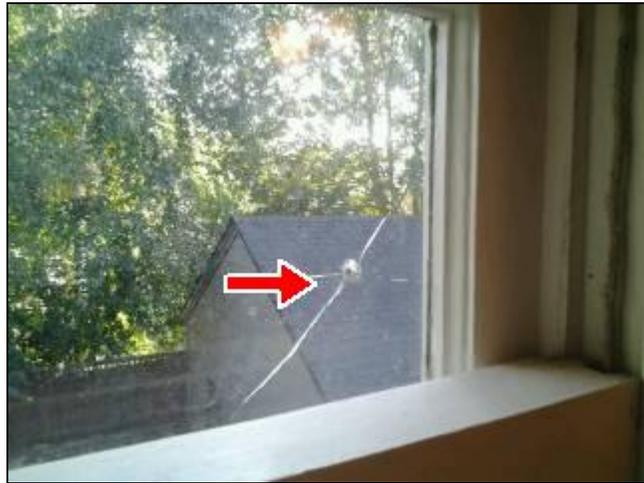
7.2.A Picture 1 stairway windows

A couple of the windows have cracked glass. I recommend the broken panes be replaced.

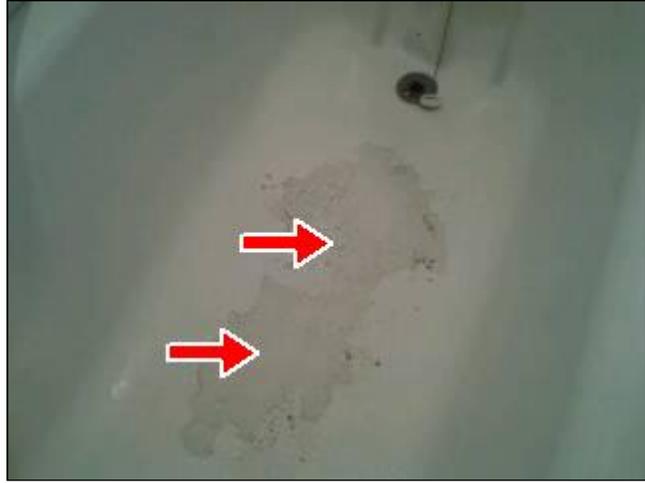
7.7.A Picture 1

tub finish is deteriorated

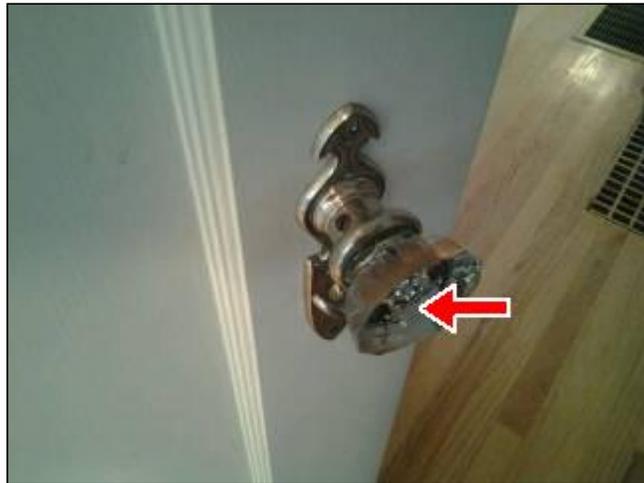
7.1.B Picture 1

repair door knob

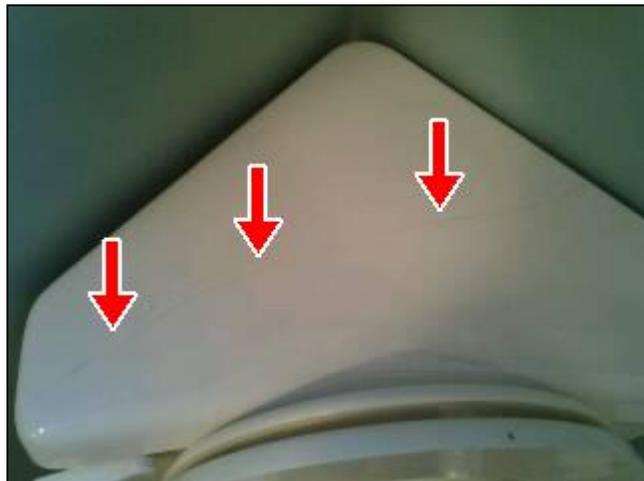
7.3.B Picture 1

the lid to the toilet tank is cracked and should be replaced.

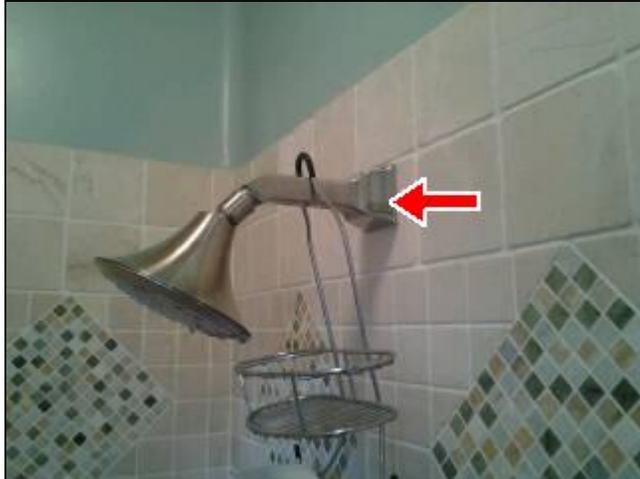
7.4.B Picture 1

The shower head or controls do not appear to be secured to a framing member and are loose in the wall. Damage from moisture penetration or broken pipes is possible. I recommend these pipes be securely attached to a framing member.

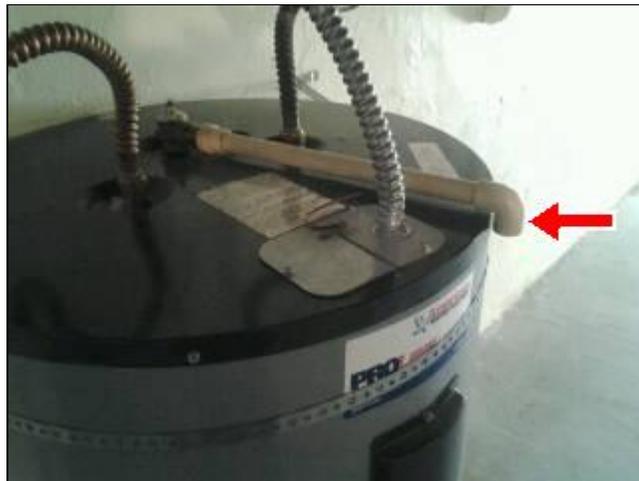
8.2 Picture 1

The T&P (Test and Pressure) valve on water heater needs a 3/4 threaded pipe to extend within 6 inches of floor for safety. (PVC is not approved for hot water use). I recommend repair by a qualified person.

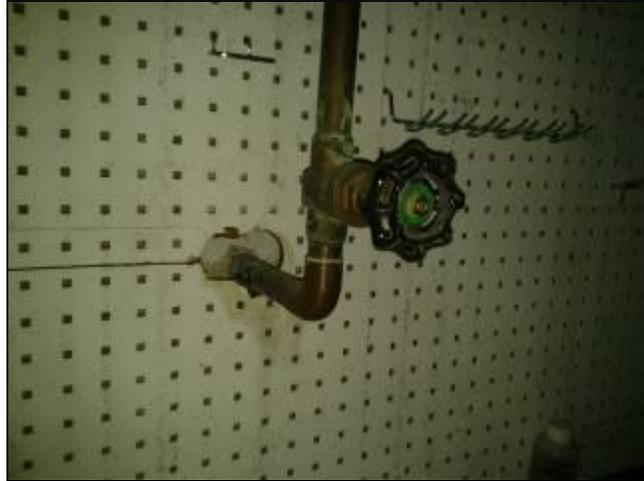
8.3 Picture 1

The main water shut off is located in the basement.

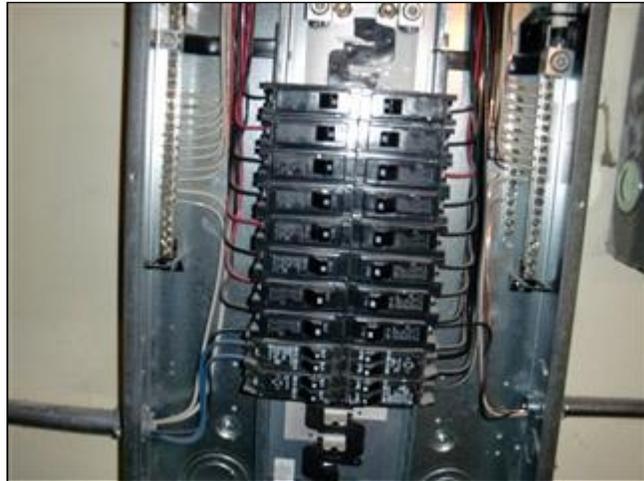
9.1 Picture 1

The panel appears serviceable.

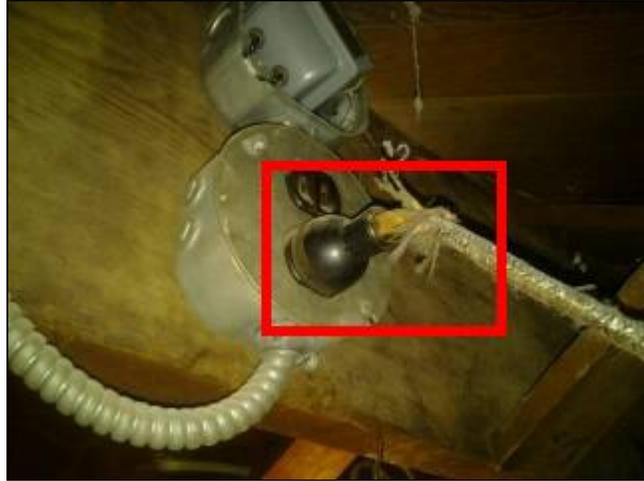
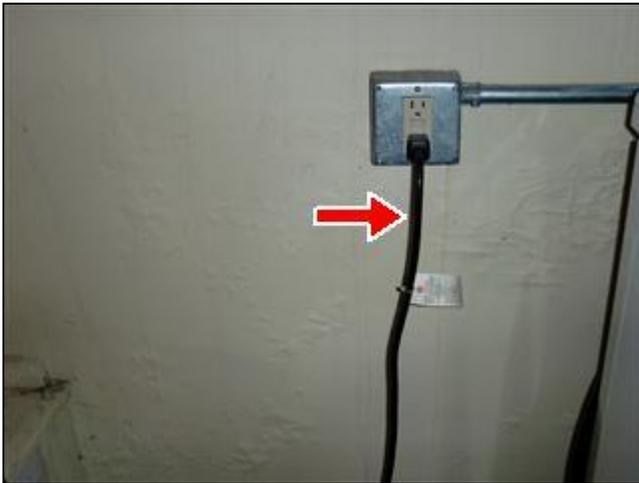
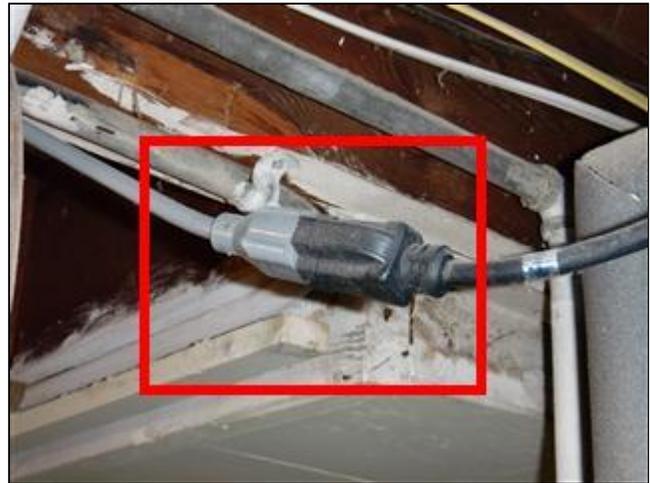
(1) Extension cords are used as permanent wiring which is a safety/fire hazard. Devices should be plugged directly into a permanent outlet. Where a permanent outlet is not available one should be installed.

(2) Extension cords are used as permanent wiring which is a safety/fire hazard. Devices should be plugged directly into a permanent outlet. Where a permanent outlet is not available one should be installed.

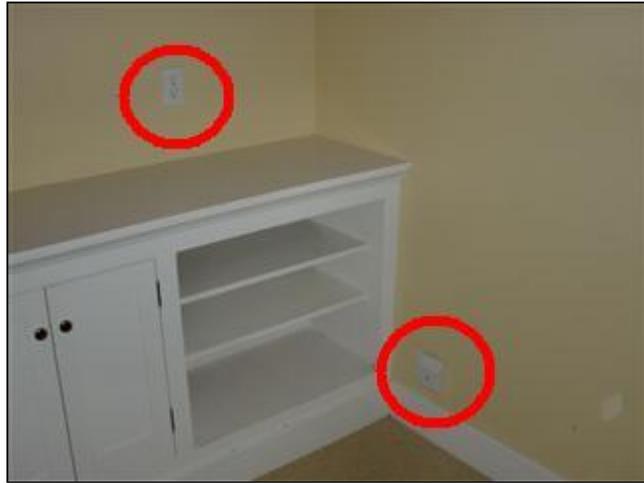
9.3 Picture 1

Open grounds at three pronged outlets and/or original 2 prong outlets are noted thru out the home. I recommend a licensed electrician make corrections as appropriate to ensure that these outlets are properly grounded. Upgrading all outlets to modern grounded 3 prong outlets is advised.

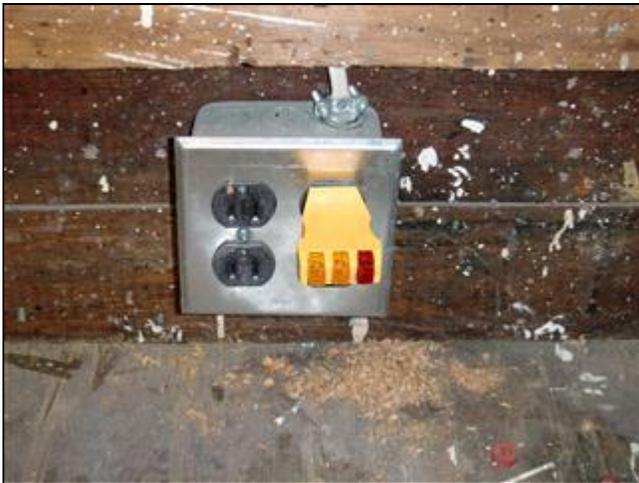
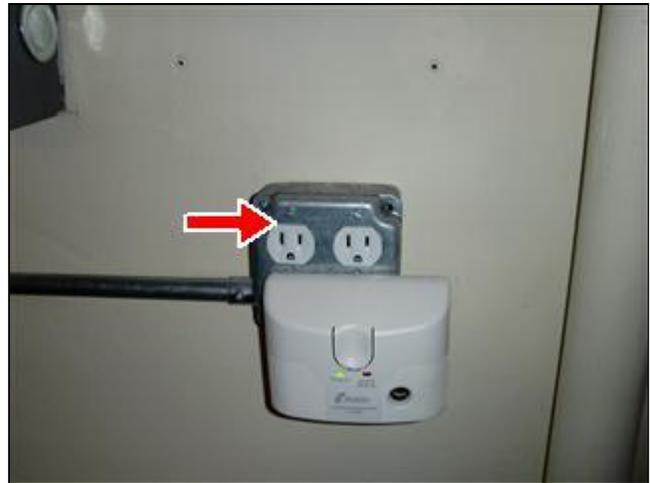
The basement outlets are not GFCI protected. Corrections are advised as a safety precaution.

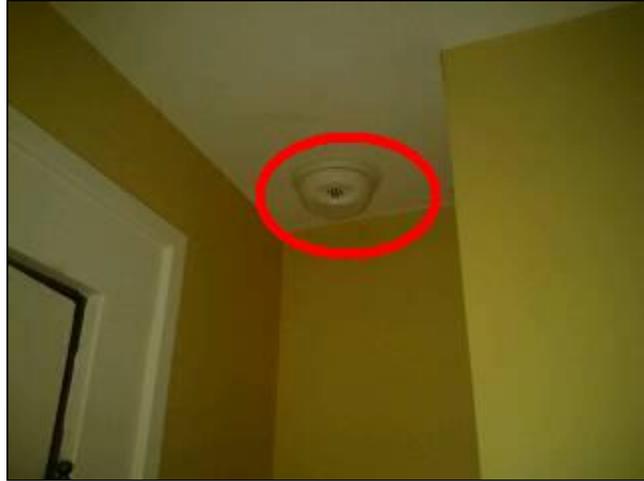
9.7 Picture 1

I recommend all smoke alarm batteries be replaced at move in and detectors to be tested weekly/monthly as per manufacturers instructions move alarm from front left bedroom to a more appropriate location

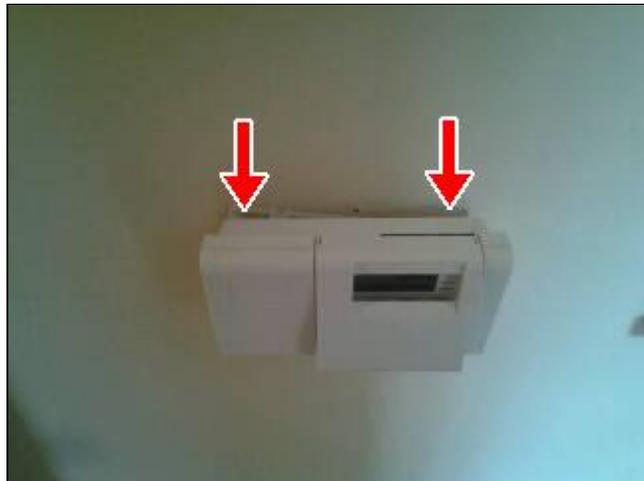
10.1 Picture 1

The thermostat is loose on wall. I recommend repair or replace as needed.

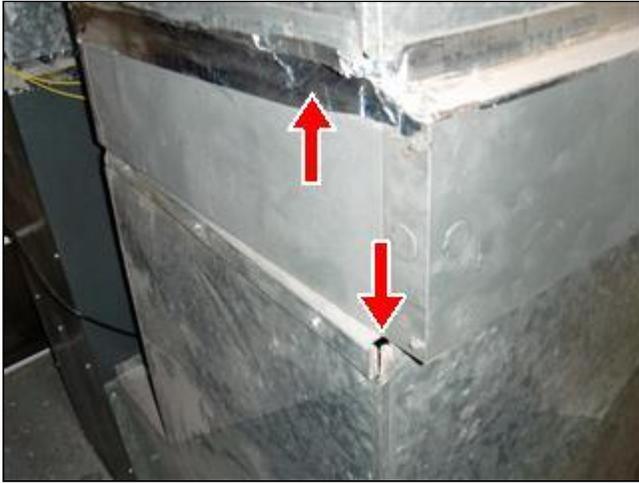
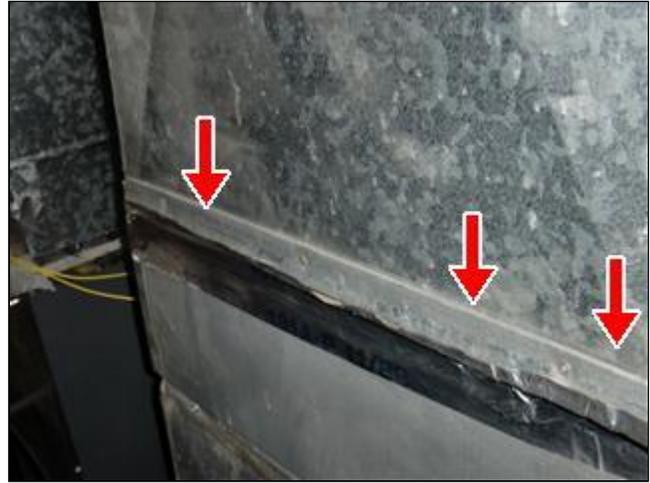
Taping is needed at plenum at the furnace to improve overall efficiency.

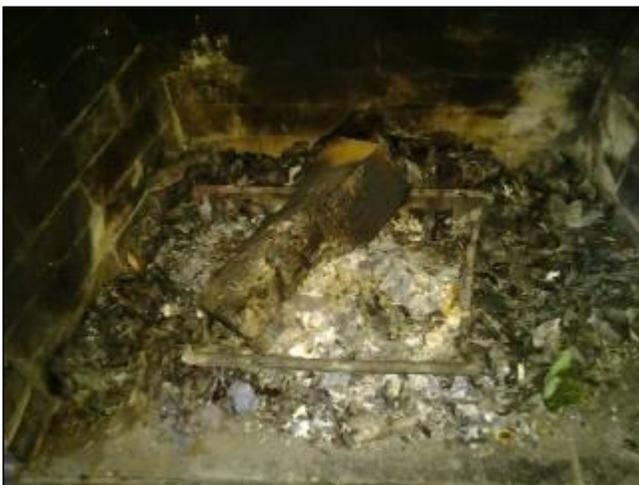
10.6 Picture 1

The fire box is full of ashes. I recommend the fireplace and chimney flue be cleaned before use.(Picture 1)

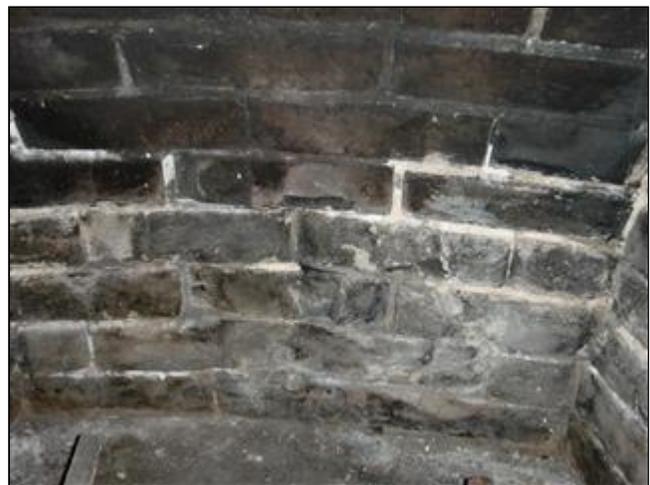
10.6 Picture 2

Deteriorated brick and mortar is noted in the firebox. A chimney repair contractor or mason should evaluate and make repairs as appropriate.(Picture 2)
